AIRCRAFT ACCIDENT  
IDENTIFICATION  
NO.

710 05 101

## NAVAVNSAFECEN MISHAP CODE SHEET

4 MAR 1968

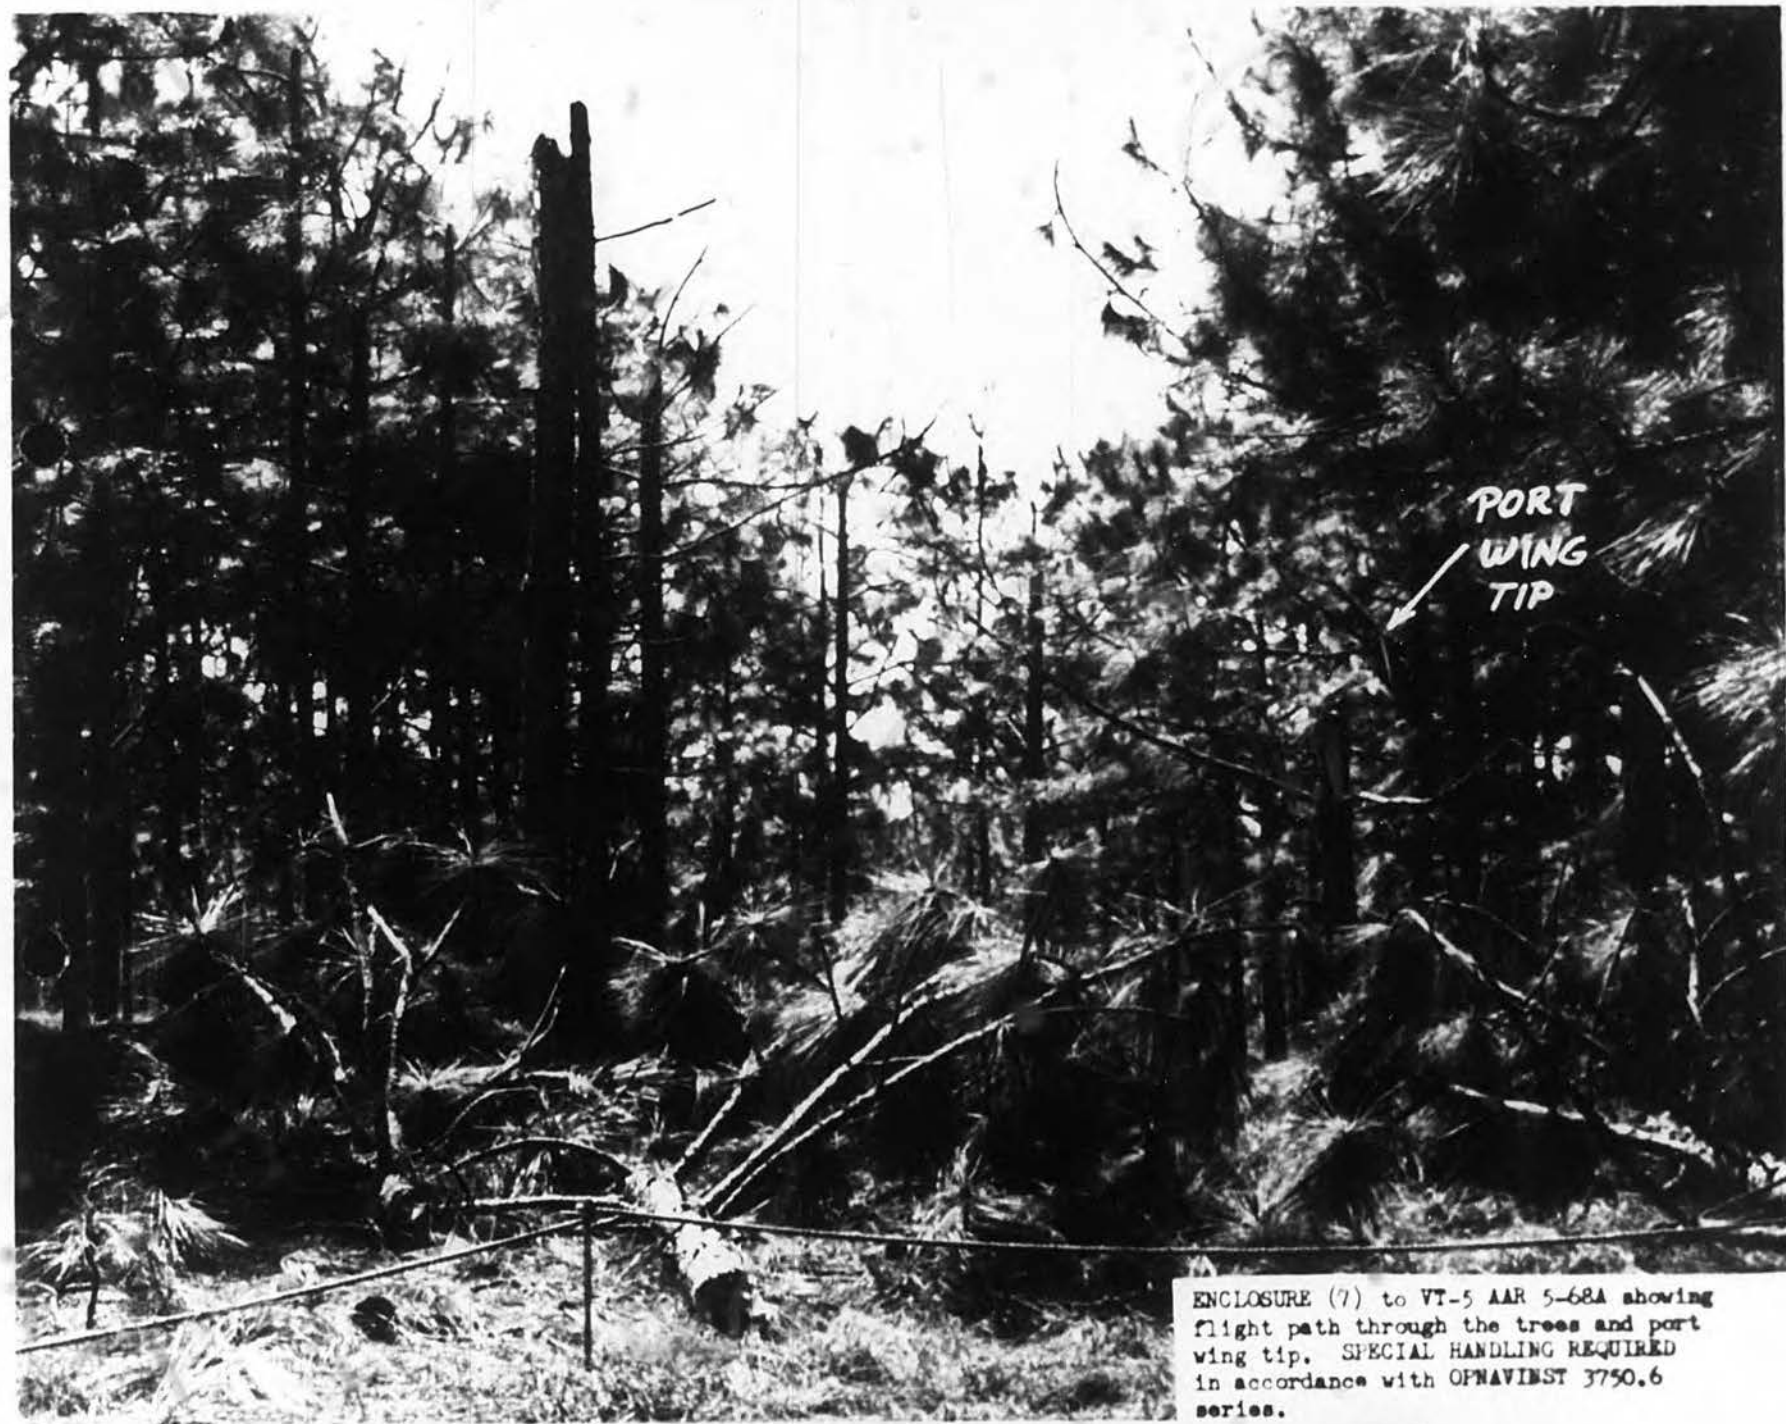
The aircraft initially hit the trees wings level, increasing it's angle of bank to the left until it reached thirty degrees. After 106 feet of travel the port wing tip struck an 8 inch diameter tree 18 feet above ground leaving the wingtip suspended in the branches (Encl (7)). The aircraft then started skidding to the right as a result of the wingtip impact, with it's left wing still down. After 191 feet of travel the port main landing gear hit the ground followed shortly thereafter by the nosewheel which broke off on impact. The skidding and the sheared nose wheel evidently caused the aircraft to flip and roll over on the starboard wing as the port wing hit an 8 inch diameter tree just inboard of the outer wing panel. It was noted that just prior to the port main landing gear touchdown, the aircraft hit and broke off two 9 inch diameter trees in the vicinity of the starboard wing root, obviously weakening it sufficiently to allow the aircraft to roll over on it. After the aircraft became inverted it skidded another 31 feet, came to rest on a heading of 300° and burst into flames. The tail section was the only major component left reasonably intact. All other major components were damaged beyond repair as a result of the impact and subsequent fire.

ENCLOSURE (7) to VT-5 AAR 5-68A showing flight path through the trees and port wing tip. SPECIAL HANDLING REQUIRED in accordance with OPNAVINST 3750.6 series.

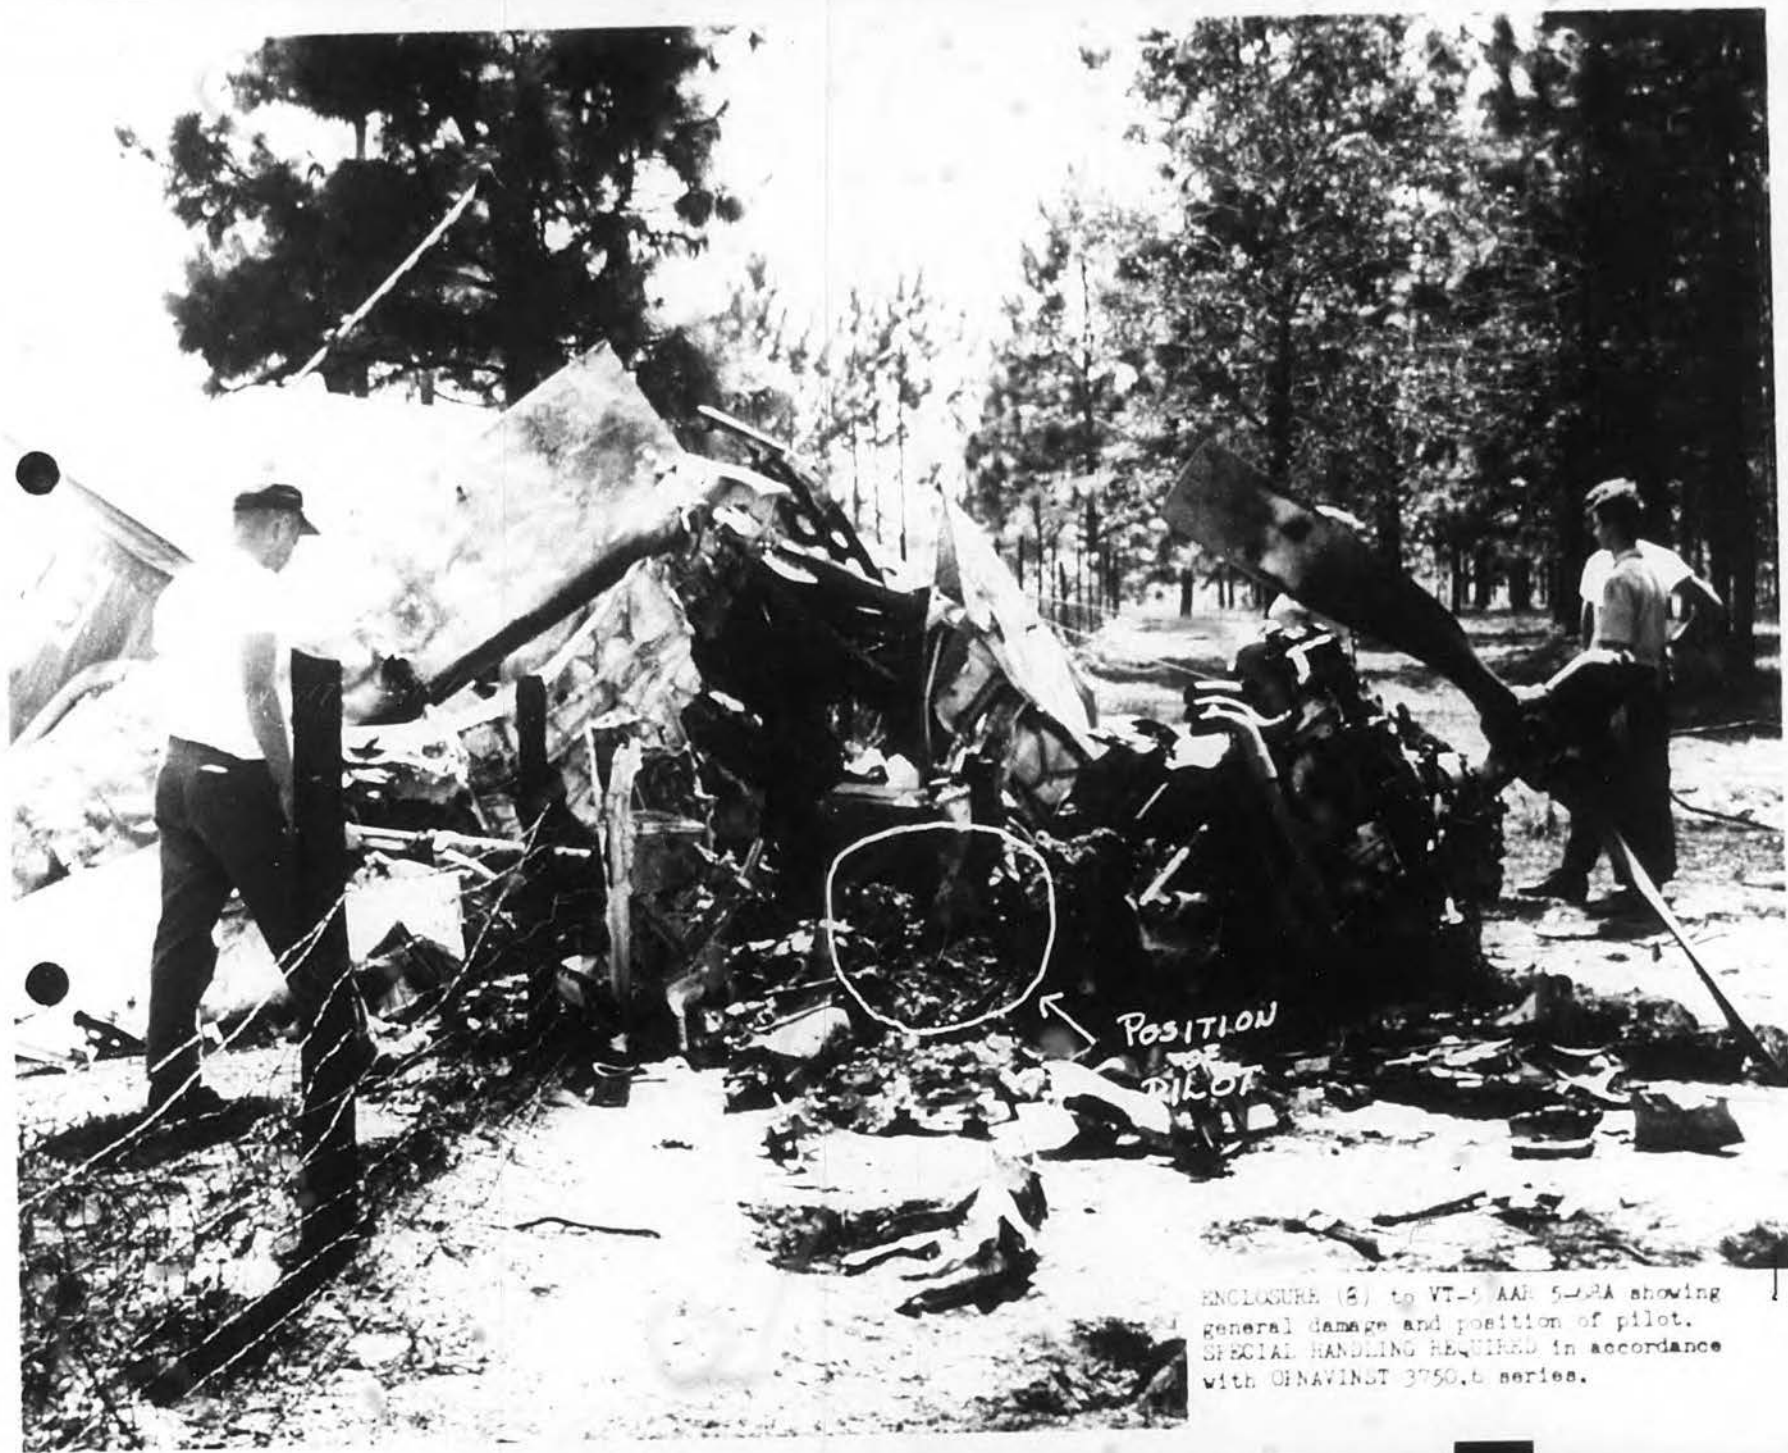
ENCLOSURE (8) to VT-5 AAR 5-2A showing  
general damage and position of pilot.  
SPECIAL HANDLING REQUIRED in accordance  
with OPNAVINST 3750.6 series.

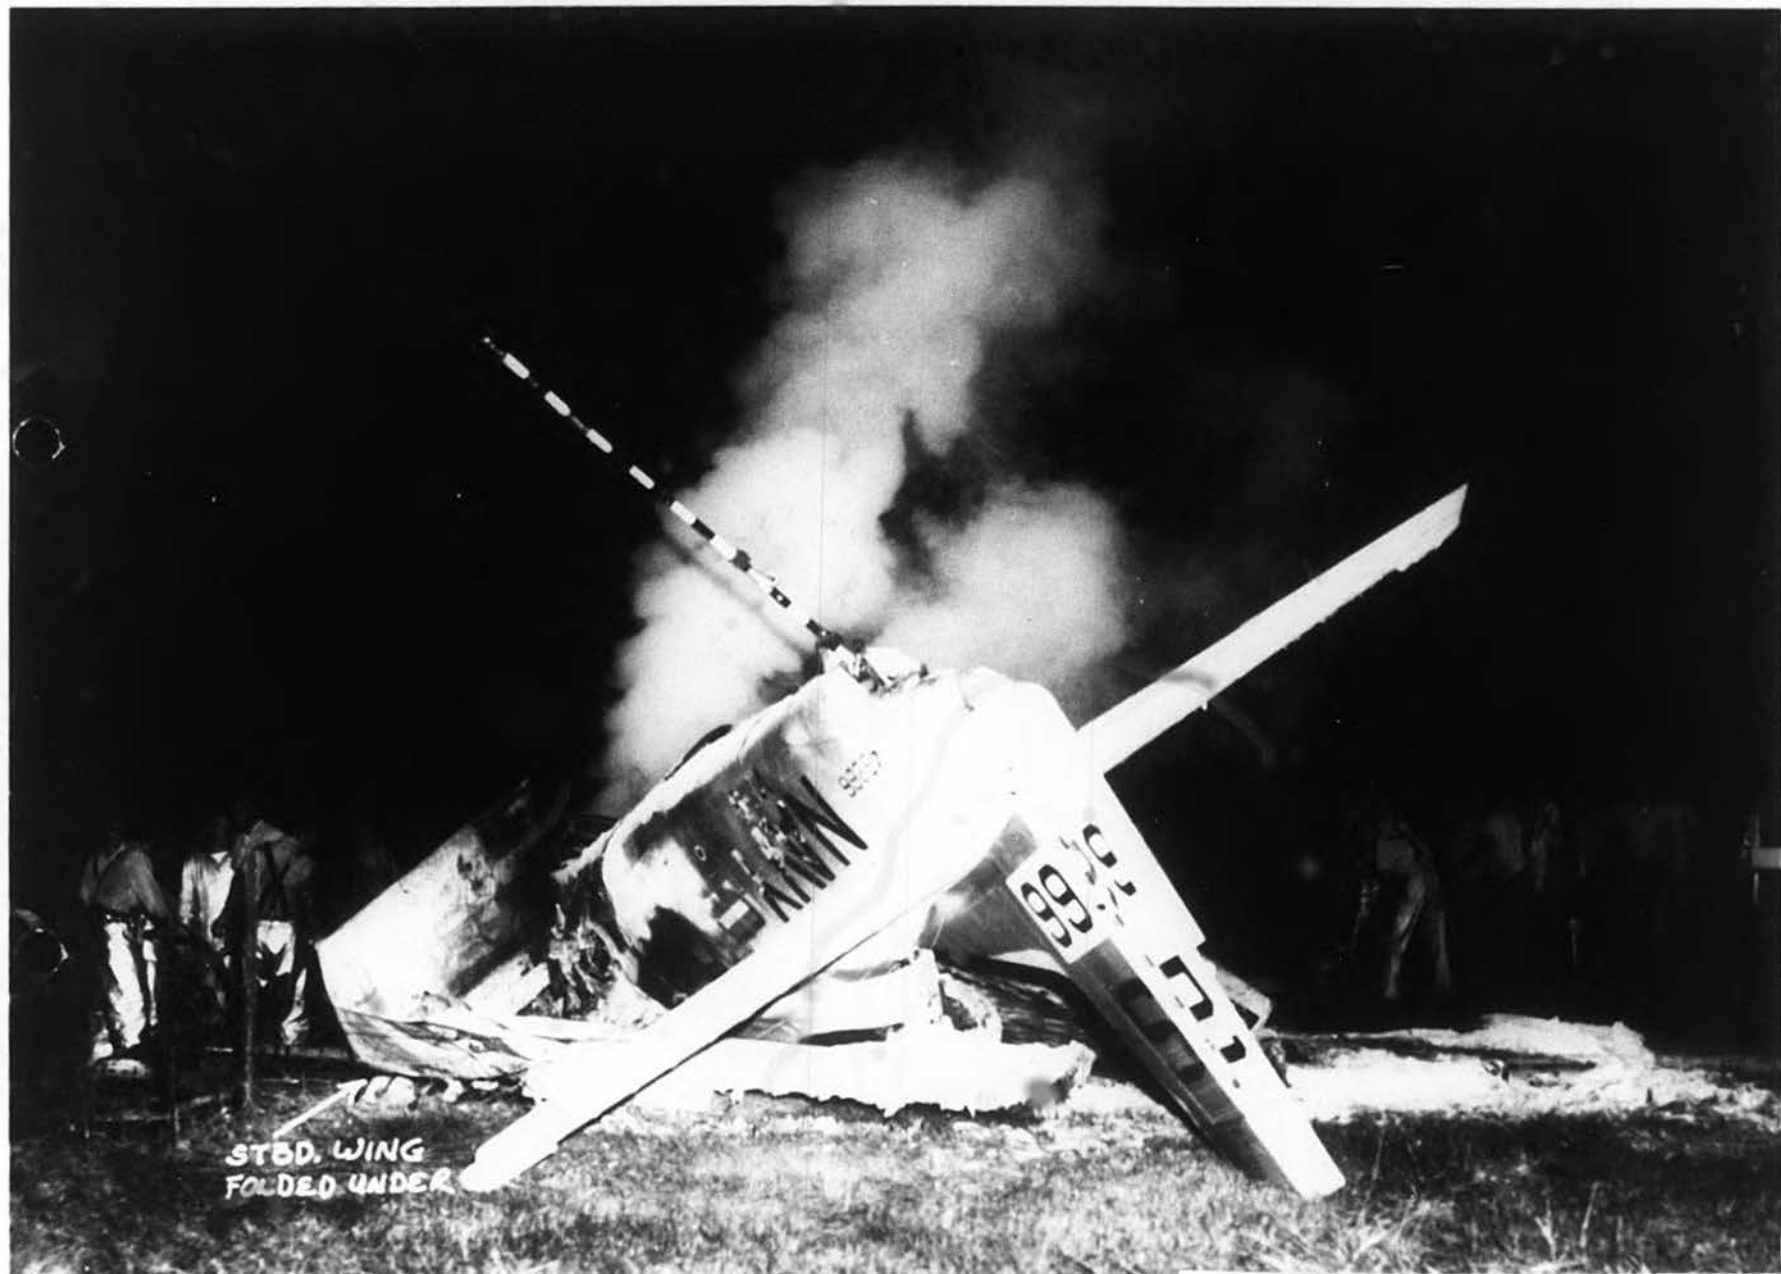
The aircraft received ALFA damage as a result of the impact damage and ensuing fire.

ENCLOSURE (1) to VT-5 AAR 5-68A showing general damage and folded starboard wing. SPECIAL HANDLING REQUIRED in accordance with OPNAVINST 3750.6 series.
